Shorefront Assessment Report Waterfront Walkway

Penobscot River
Bucksport, Maine

September 26, 2022
Project 2201829

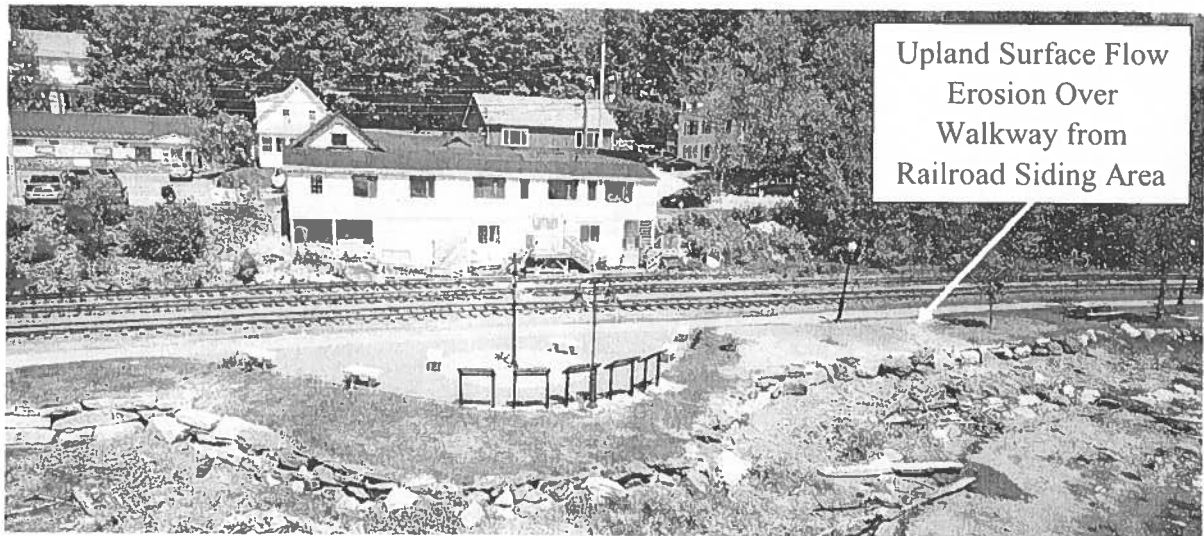
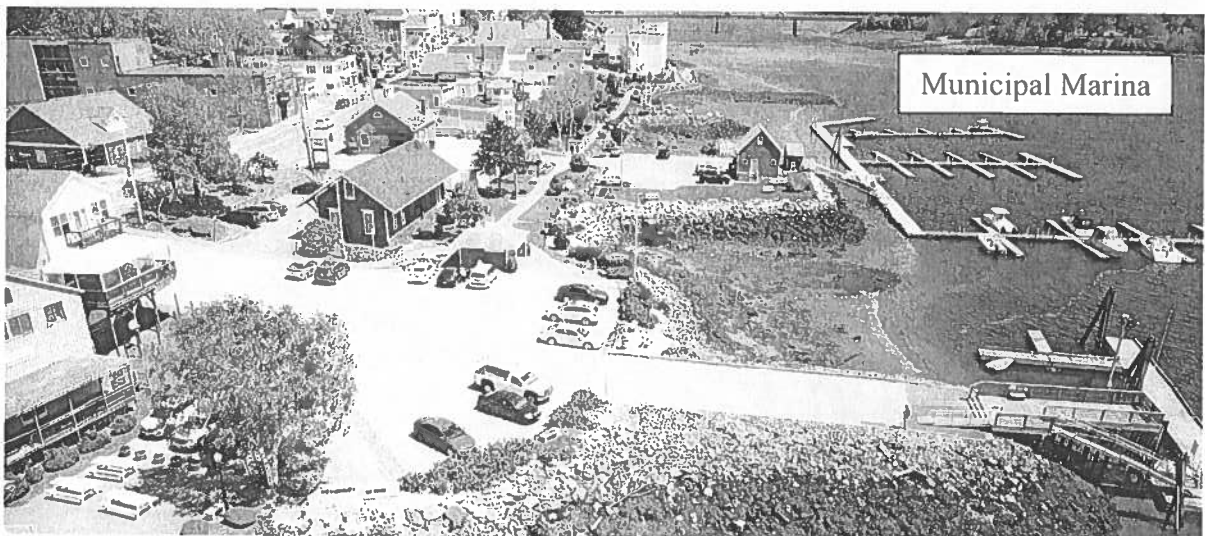
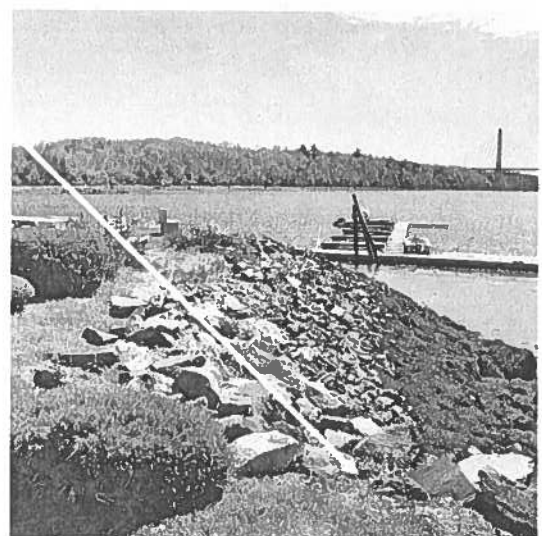
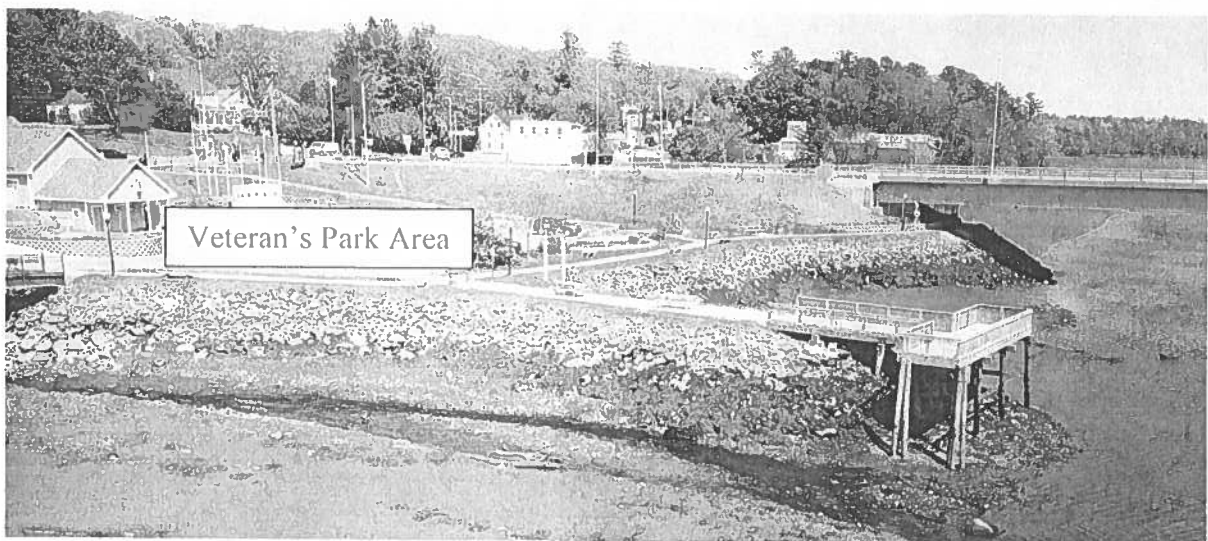
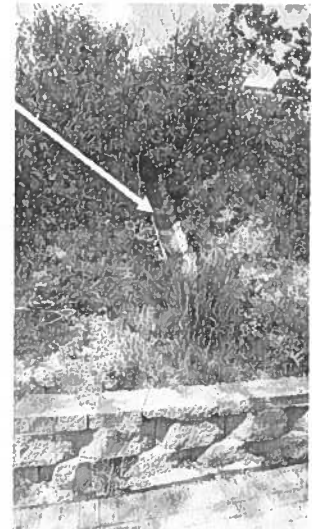
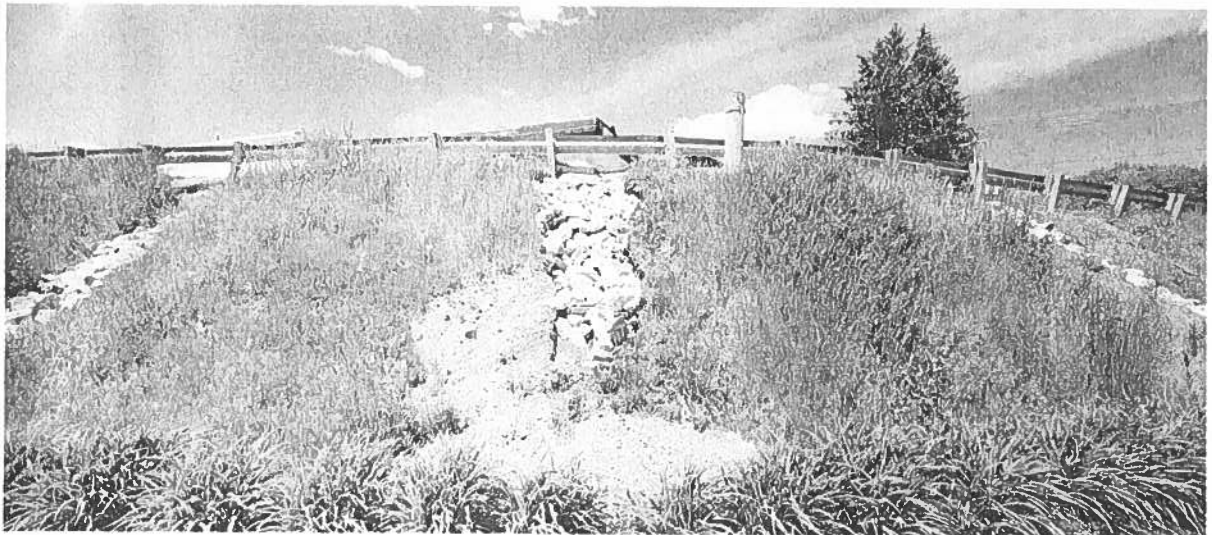
- Adjacent riprap shore frontage is generally in fair condition. Some minor erosion at the top of the riprap in adjacent lawn areas is occurring when either tidal waters periodically reach above the stone armoring, or when lawn areas have been lost, potentially due to mowing or prolonged drought conditions.

- The walkway and adjacent upland areas immediately above the riprap shorefront are experiencing various levels of erosion. The sources of these eroding conditions are upland properties contributing surface flows, and piped stormwater discharge onto and over the walkway, and from a downspout directly over the edge of the walkway where it passes under the Maine Department of Transportation's (MaineDOT) bridge to Verona Island.

The following photographs document the existing site conditions and highlight areas experiencing erosion, as well as other areas for potential shorefront stabilization improvements along the Waterfront Walkway. The majority of the images were obtained by GEI on May 25, 2022, with the last two images at the Irving Station provided by the Town of Bucksport on June 2, 2022.

- Continue to work with upland contributors to erosion due to stormwater surface flows and piped discharge impacts. These improvements may require collaboration between the Town and the property owners, given conditions of easements and rights-of-way for the Waterfront Walkway where it crosses private property. If necessary and where applicable, local, state and/or federal regulatory enforcement may be required.

- Where upland stormwater surface flows and discharges are from public properties and public rights-of-way, GEI recommends intercepting the drainage above the walkway and discharging it through existing stormwater outfalls near the bottom of riprap armored shorefront areas.

- In addition to improvements to stormwater conveyance, the Town should consider replacing lawn areas and establishing a low growth vegetative buffer between the walkway and riprap shore frontage to prevent further erosion at the top of the riprap embankments.

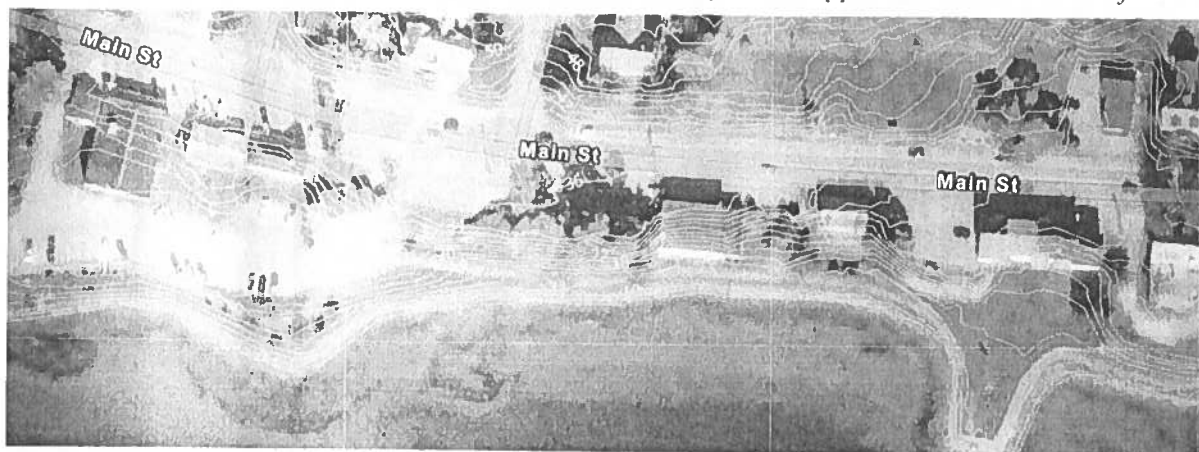
Maine Geological Survey Web LiDAR Mapping Data Image Clip

* Waterfront Walkway estimated average elevation grade at 11-feet is based on review of Maine LiDAR contour data, "Combined Sewer Overflow Abatement" 2007 plans by Wright-Pierce and "Topographic Survey; 94 Main Street" 2020 plan by Little River Land Surveying, Inc. The majority of the Waterfront Walkway grade is at or just below 11-feet. The grade rises in the middle of the walkway to approximate elevation 23-feet and at the easterly end to approximate elevation 23-feet.

Based on readily available LIDAR contour data, the top of the embankment is at approximate elevation 10-ft and the majority of the walkway is at approximate elevation 11-ft, which indicates that the embankment and portions of the adjacent upland could be overtopped during a 100-year flood event based on the FEMA flood elevations noted above. Such events could cause erosion of the embankment and immediately adjacent upland areas, especially given their classification as V-zones which indicates calculated wave heights with a minimum height of 3-feet impacting the area during a 100-year flood event.
